## **ENGINEER'S REPORT**

# **JOINT DRAINAGE DISTRICT NO. 35-89 LATERAL 12 WATERWAY WINNEBAGO & KOSSUTH COUNTY, IOWA**

**PROJECT NO: E26056**

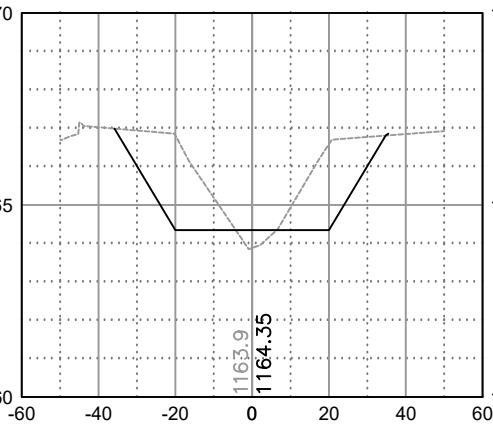
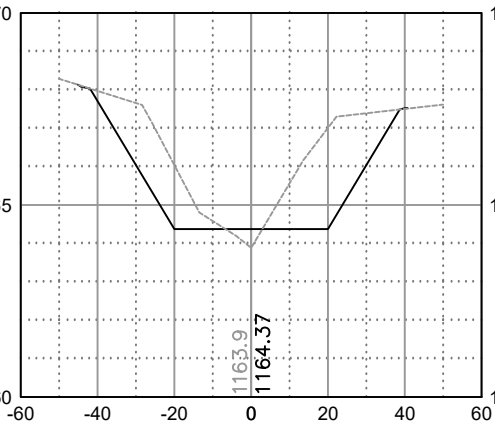
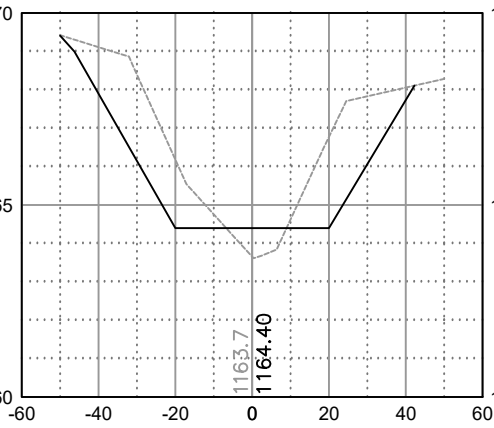
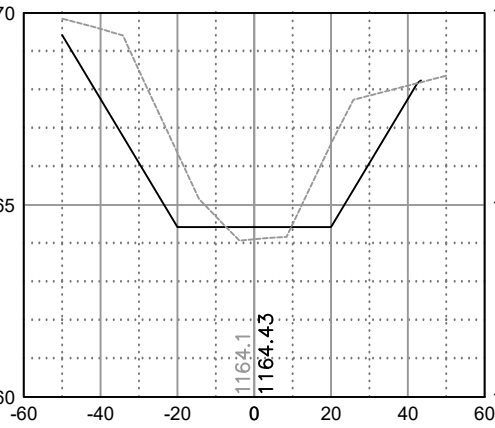
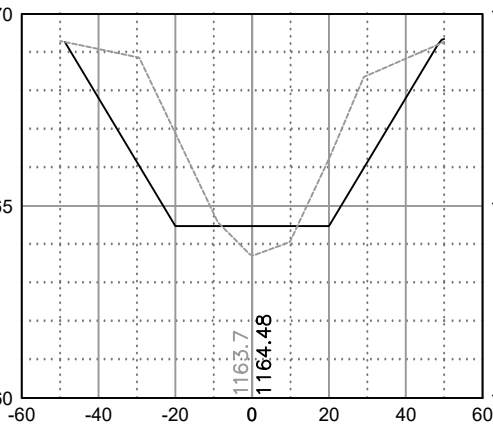
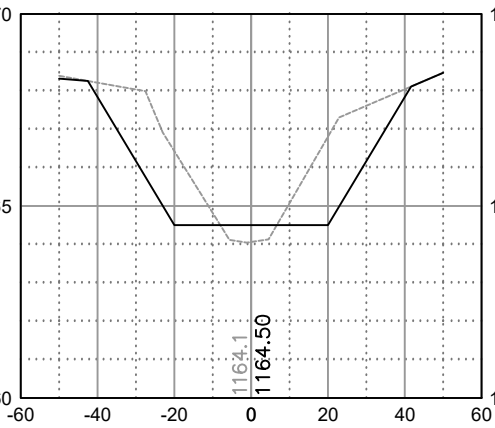
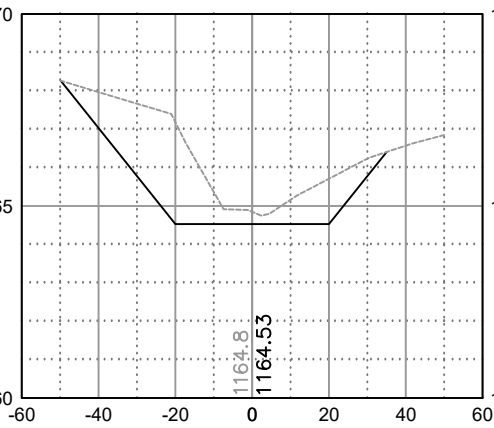
As can be seen in the enclosed cross-sectional views, in the reach from approximately STA 34 – 42 the waterway is quite deep and does not appear to have anywhere near a 40 foot wide bottom. We speculate that perhaps this reach was never excavated with a 40 foot wide bottom. The narrow corridor likely eroded, causing it to deepen below the design bottom elevation and was eventually seeded to grass (the only portion of the entire waterway that is grassed and not farmed). The original cut in this reach was over 2 ½ feet, which means the side slopes of the waterway was allowed to be 6:1 (rather than the 8:1 called for elsewhere). Widening/re-widening the waterway in this reach should strongly be considered.
